April 11, 2011

Re: Construction Stormwater Violations at Mercy North, TNR133683

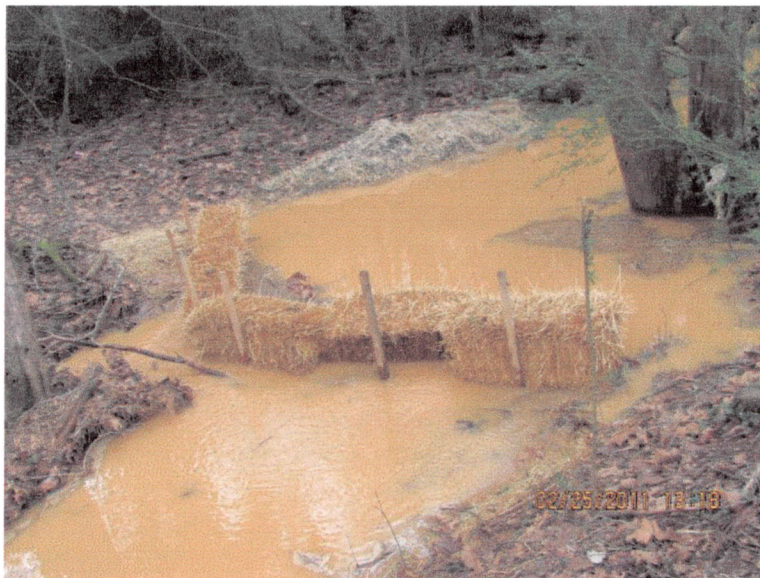
There have been numerous occasions when Mercy North has discharged stormwater containing excess sediment in violation of Sections 3.5.3.1(a) & 3.1 of the CGP. This discharge is from the west side of the Mercy North property to a tributary of Beaver Creek behind Bishop Road. This photograph documents the failure of Mercy North to control the discharge of sediment-laden water on February 25, 2011:

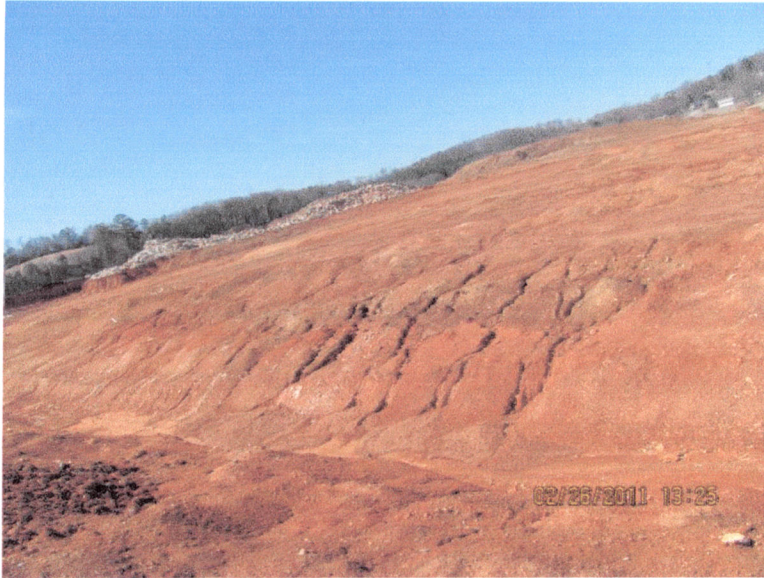
As a general matter, there are insufficient best management practices in place to prevent water from eroding rills and gullies throughout the site in violation of Section 3.5.3.1(b) of the CGP. The formation of these rills and gullies indicates that the eroded materials have been mobilized and are migrating offsite, as documented in this February 26, 2011 photograph:

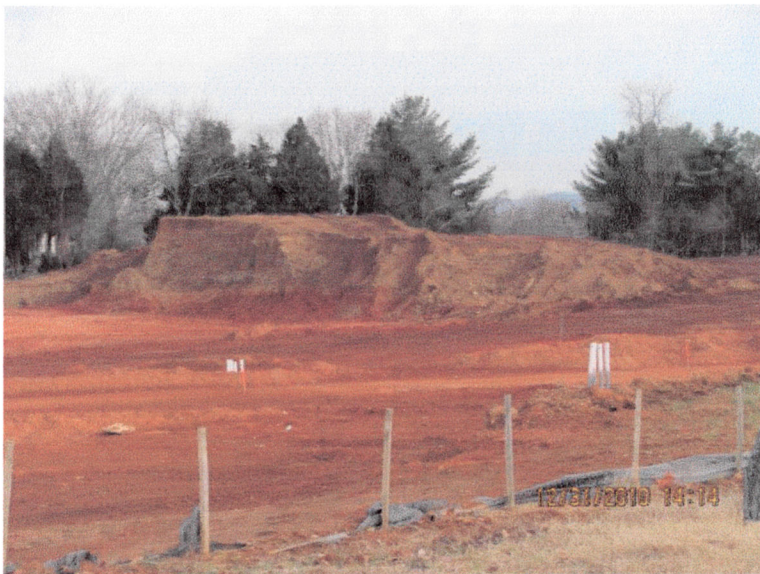
In addition, there is a lack of inlet protection and a lack of adequate erosion prevention and sediment controls. For example, some silt fences at the site are not properly installed and maintained, as shown in this picture:
